Evaluate Two High Performance Engines
Wessinger
Ms. Lucy Webster
Location Not Applicable To File

June 13, 2011

REFERENCE: Evaluate Two High Performance Engines
Client: Wessinger
McGowan Hood & Felder File Number: 02-11-0062
ED&T File Number: COL15183-57153

The following is a report concerning an investigation of two high performance engines that were assembled by Tyler Crockett Marine Engines. The purpose of this investigation has been to evaluate the mechanical condition of the two engines to determine whether the quoted work was completed.

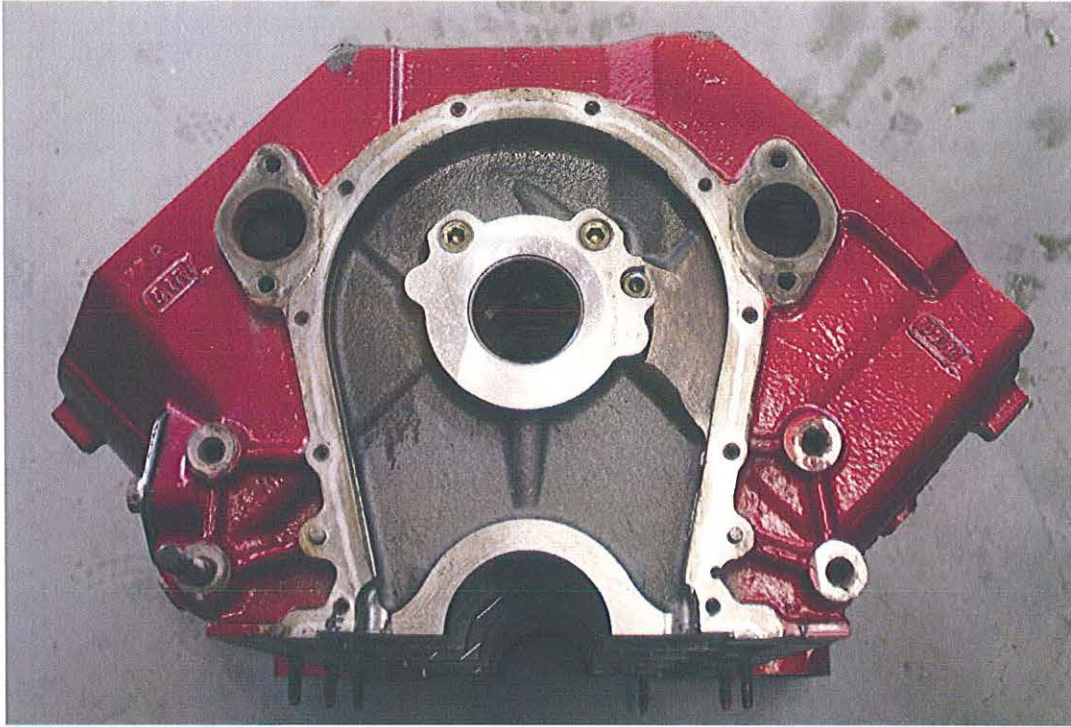
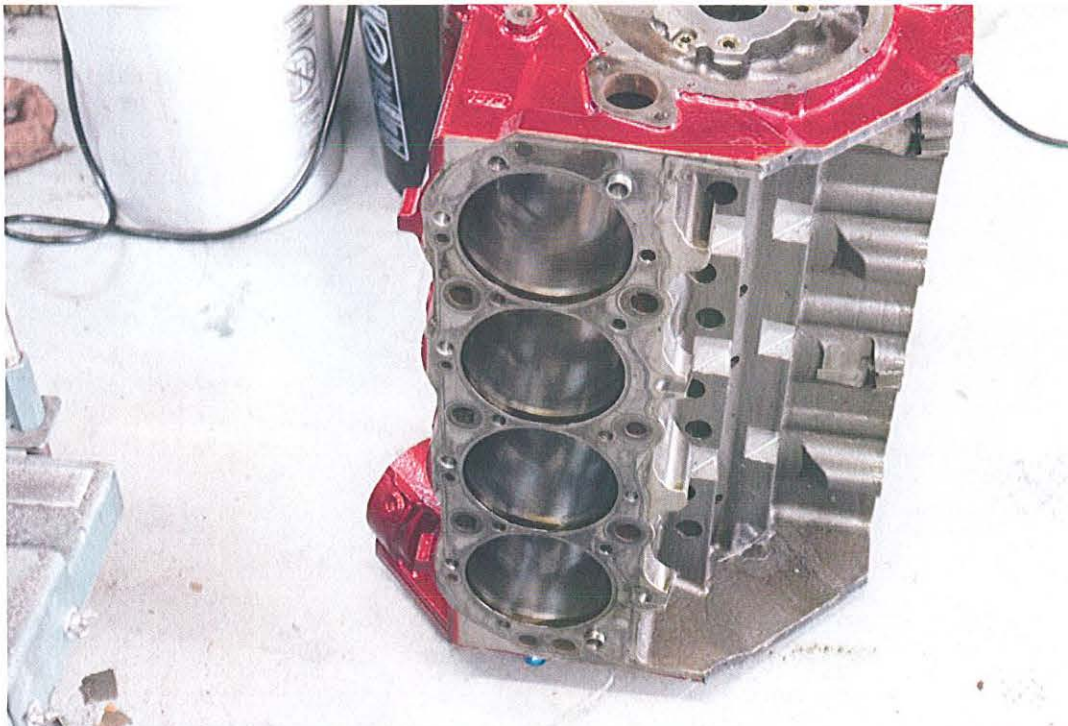
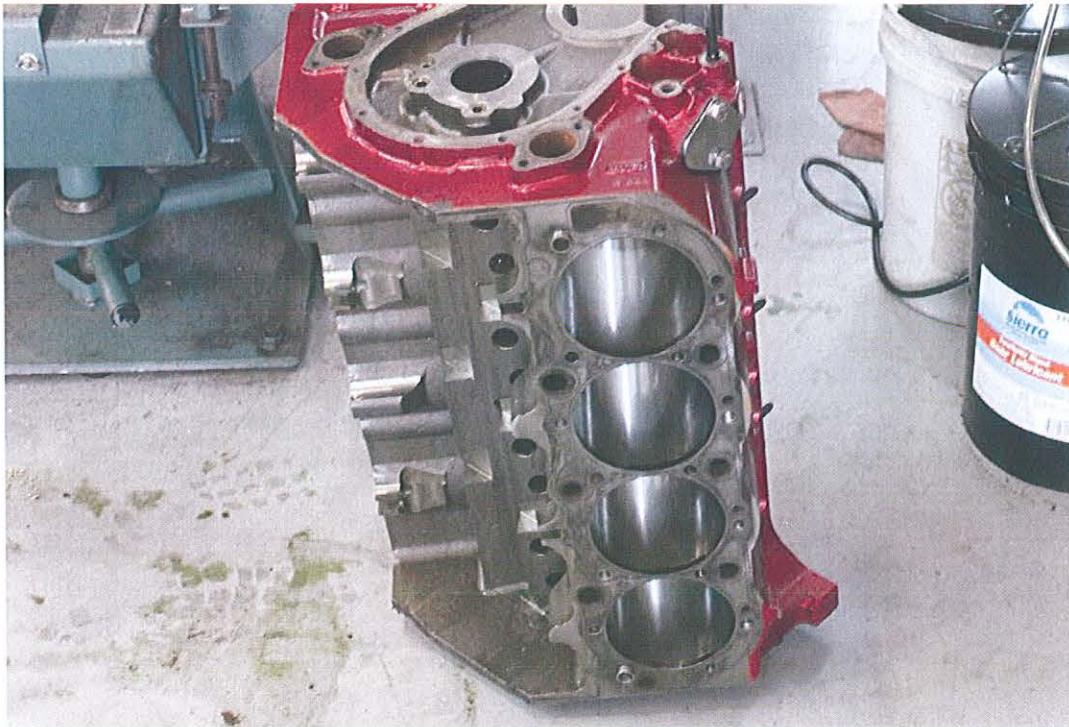
The overall condition of the engine block from this engine is shown in figures A1-A3. The mechanical conditions of the engine components were examined. This included an examination of the engine block, cylinder walls, cylinder heads, intake and exhausts valves, piston heads, piston connecting rods, piston pins, piston rings, crankshaft, the associated bearings and bushings, valve covers, and oil pan. Longitudinal scratches were observed on some cylinder walls as shown in example in Figures A4-A5. Some of the connecting rod bearings exhibited signs of severe metal to metal contact and a degradation of the lubricating oil film between the bearings and the crankshaft as shown in example in Figures A6-A7. Some of the main bearings exhibited severe degradation damage and others less severe damage from metal to metal contact and discoloration from excessive heat as shown in example in Figures A8-A9. Some of the piston pin bushings installed in the connected rods exhibited discoloration that was indicative of excessive heat in the area as shown in example in Figures A10-A11. The oil pan was damaged in the form of deformation to the bottom of the pan and metal shavings were also observed at the bottom of the pan as shown in Figure A12.

Figure A1 #377R: Front of block (image cropped)

Figure A2 #377R: Cylinders 1,3,5, and 7

Figure A3 #377R: Cylinders 2,4,6, and 8 (image cropped)

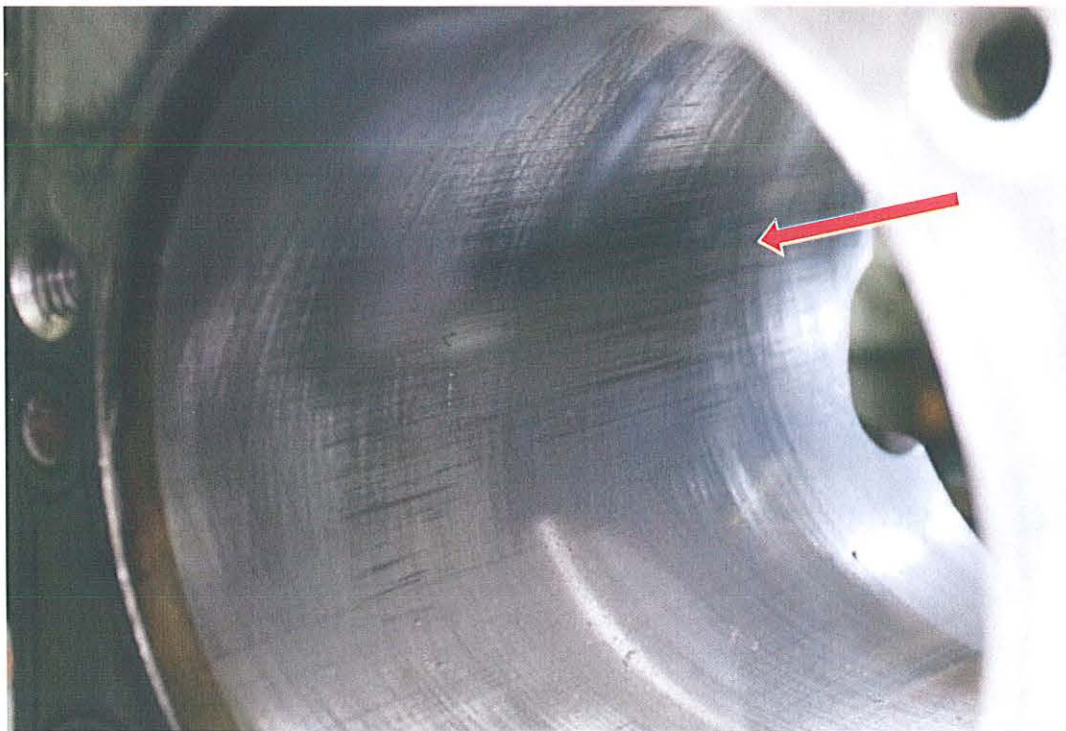
Figure A4 #377R: Lateral scratches on cylinder #3 wall, arrow indicates direction of scratching

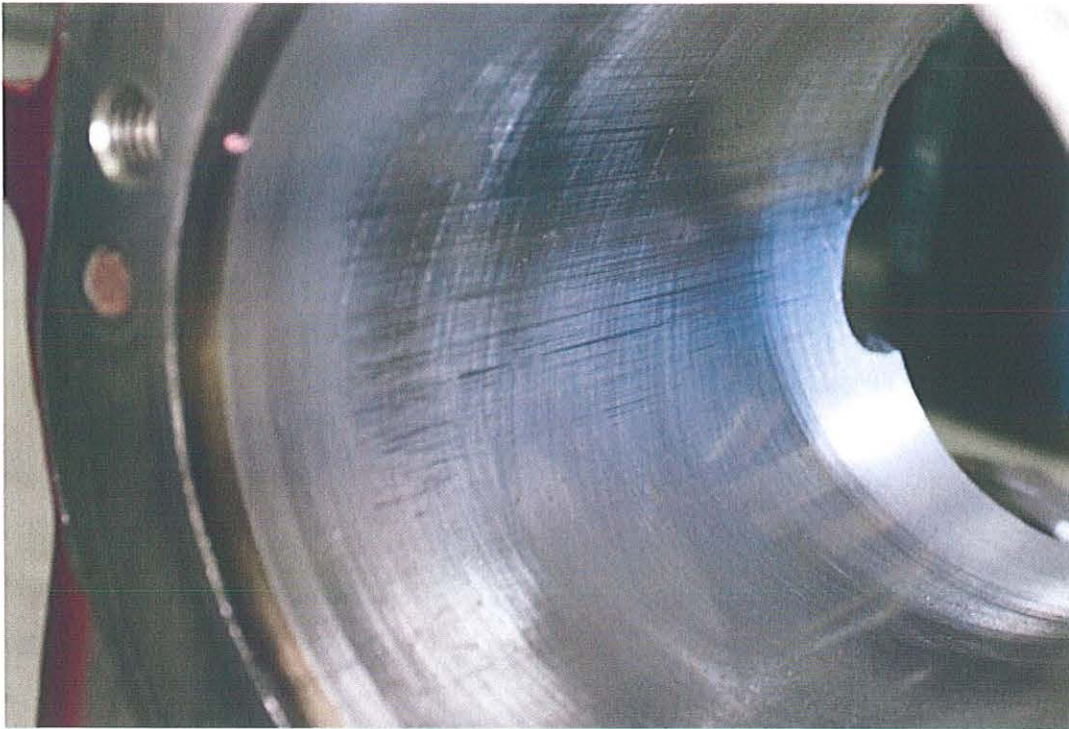
Figure A5 #377R: Lateral scratches on cylinder #7 wall, arrow indicates direction of scratching

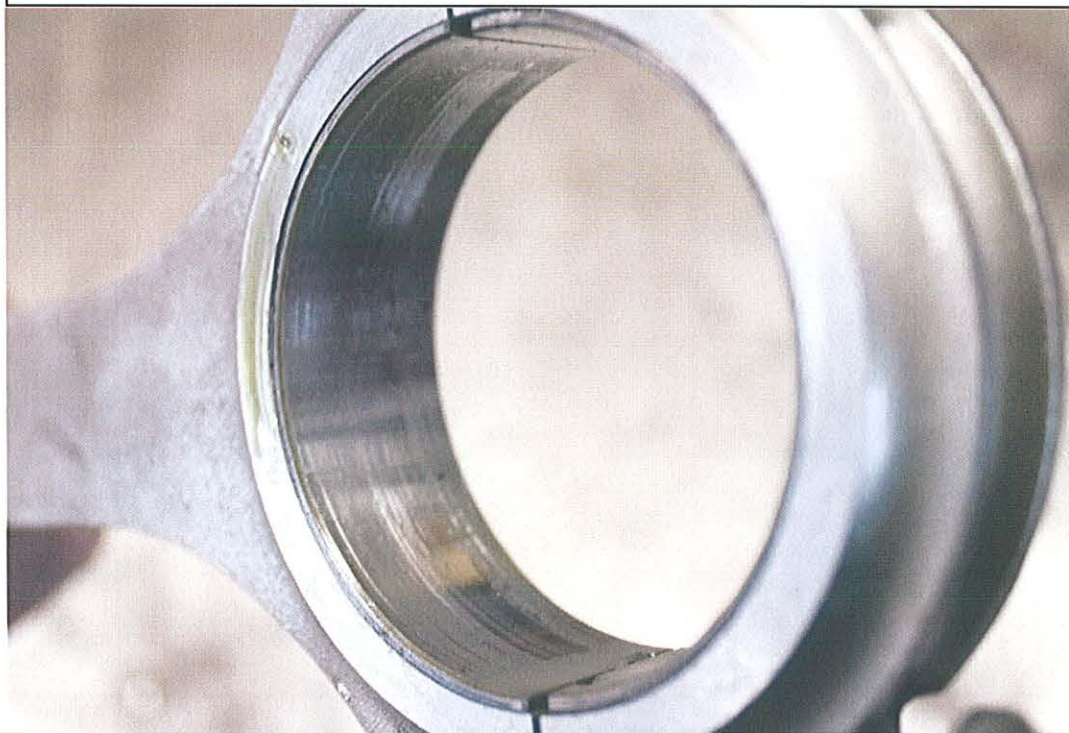
Figure A6 #377R: Indication of metal to metal contact on cylinder #3 connecting rod bearing (image cropped)

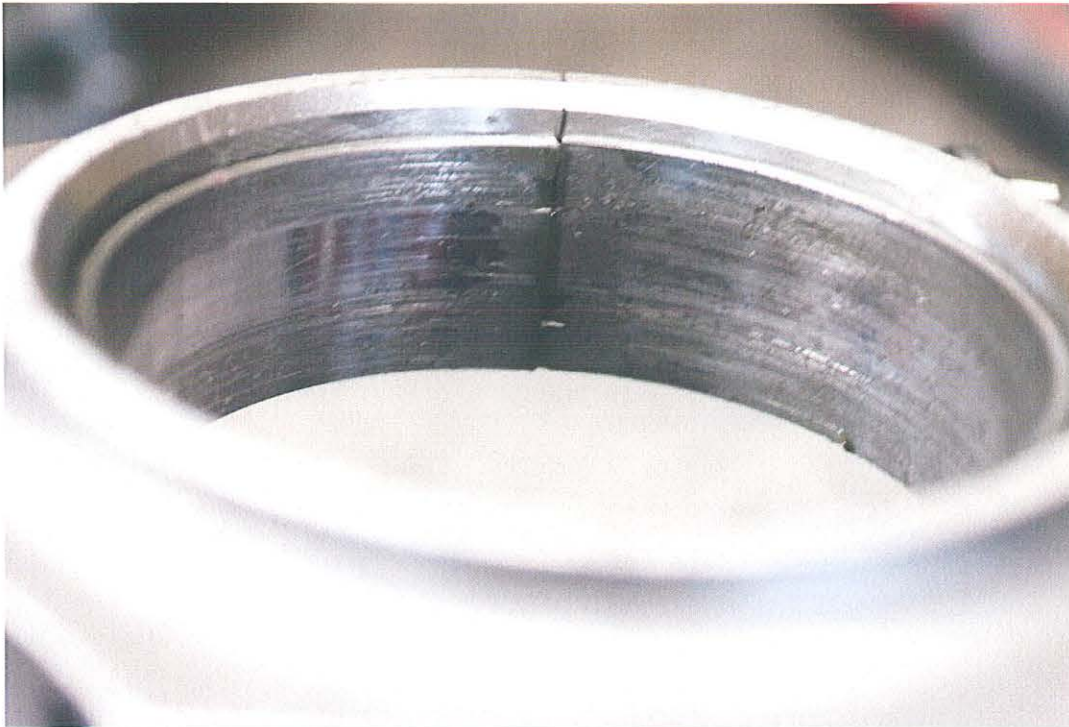
Figure A7 #377R: Indication of metal to metal contact on cylinder #2 connecting rod bearing (image cropped)

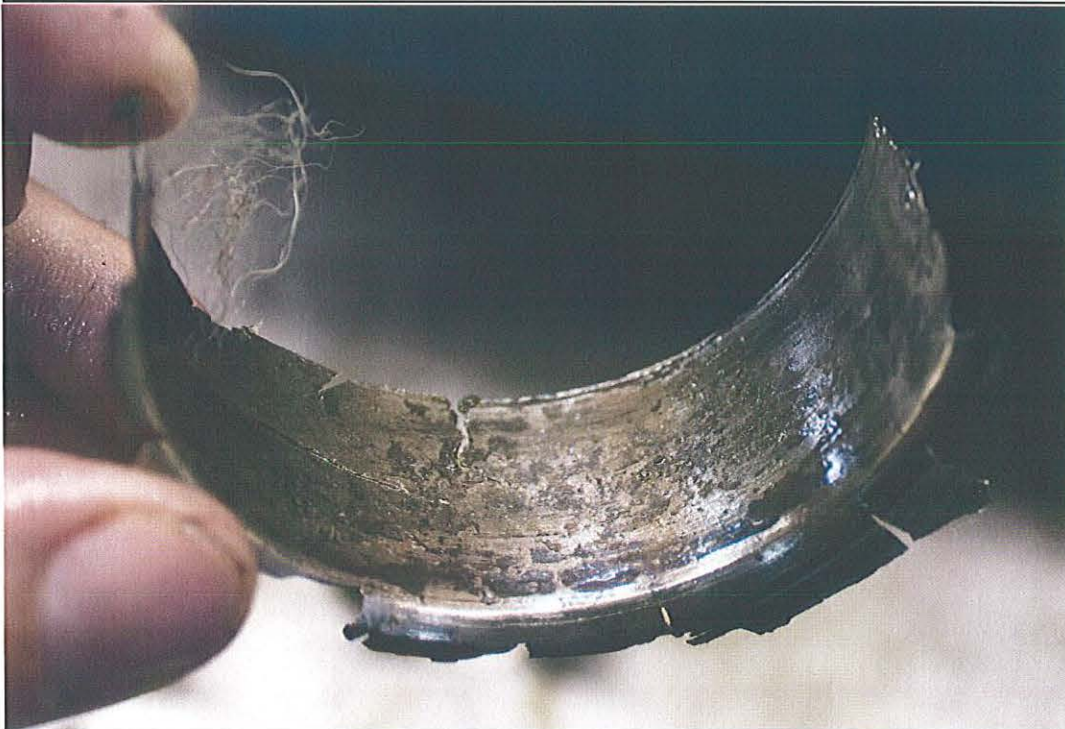
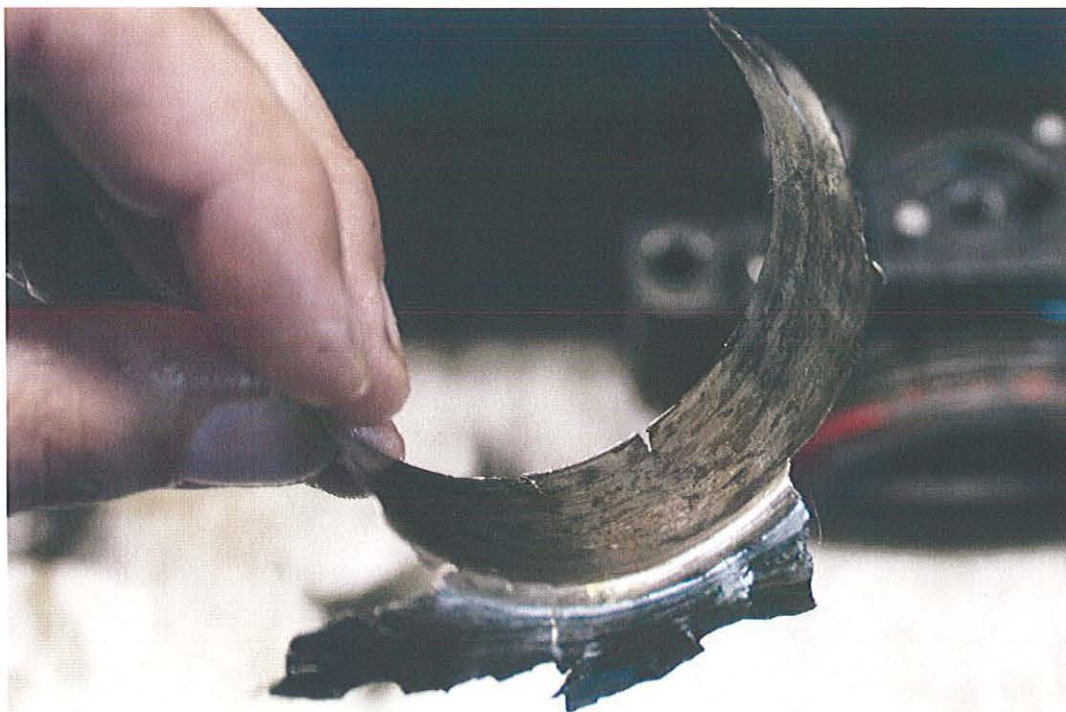
Figure A8 #377R: Severe damage to main bearing – unknown location on crankshaft (image cropped)

Figure A9 #377R: Severe damage to main bearing – unknown location on crankshaft (image cropped)

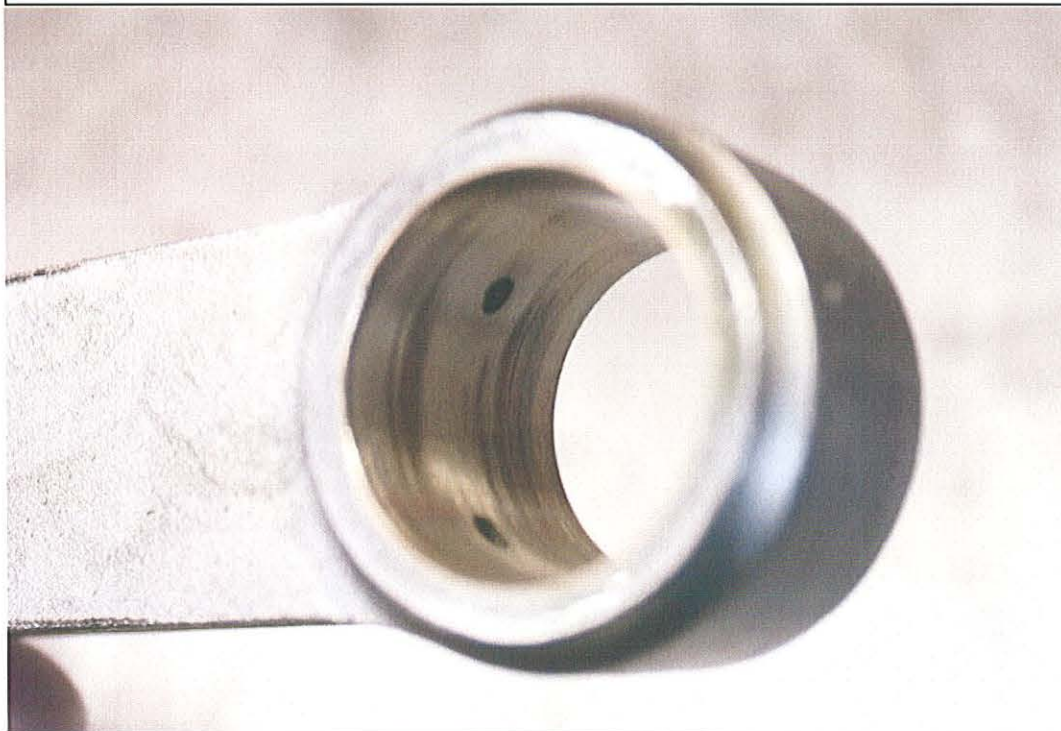
Figure A10 #377R: Damage to piston pin bushing cylinder #1 (image cropped)

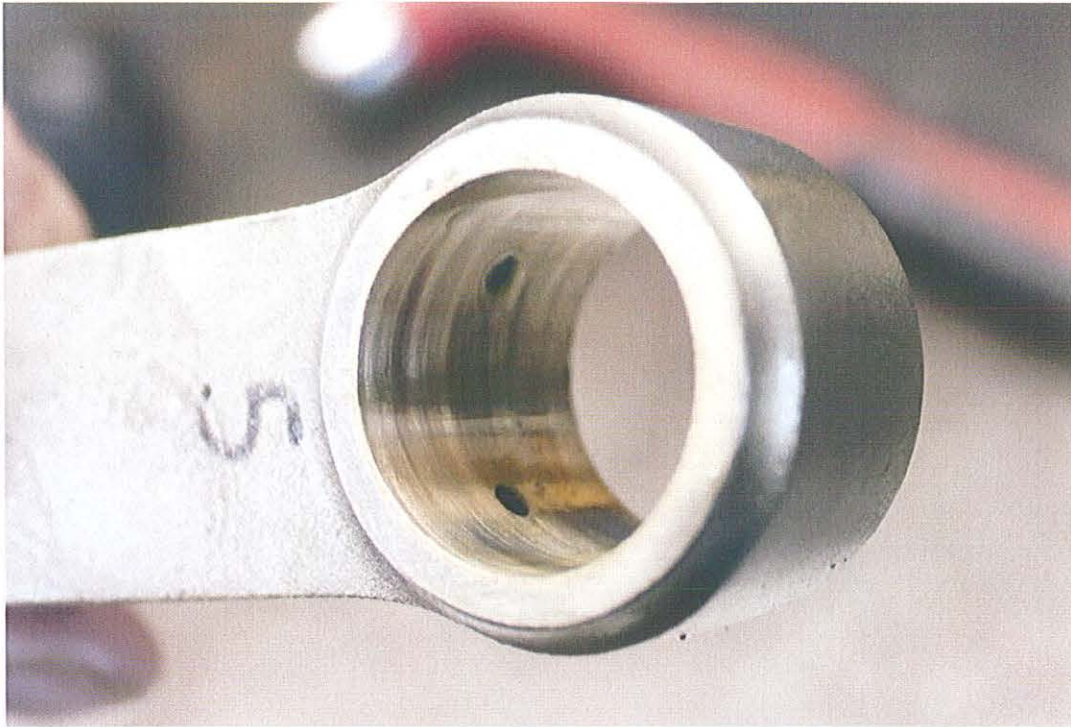
Figure A11 #377R: Damage to piston pin bushing cylinder #5 (image cropped)

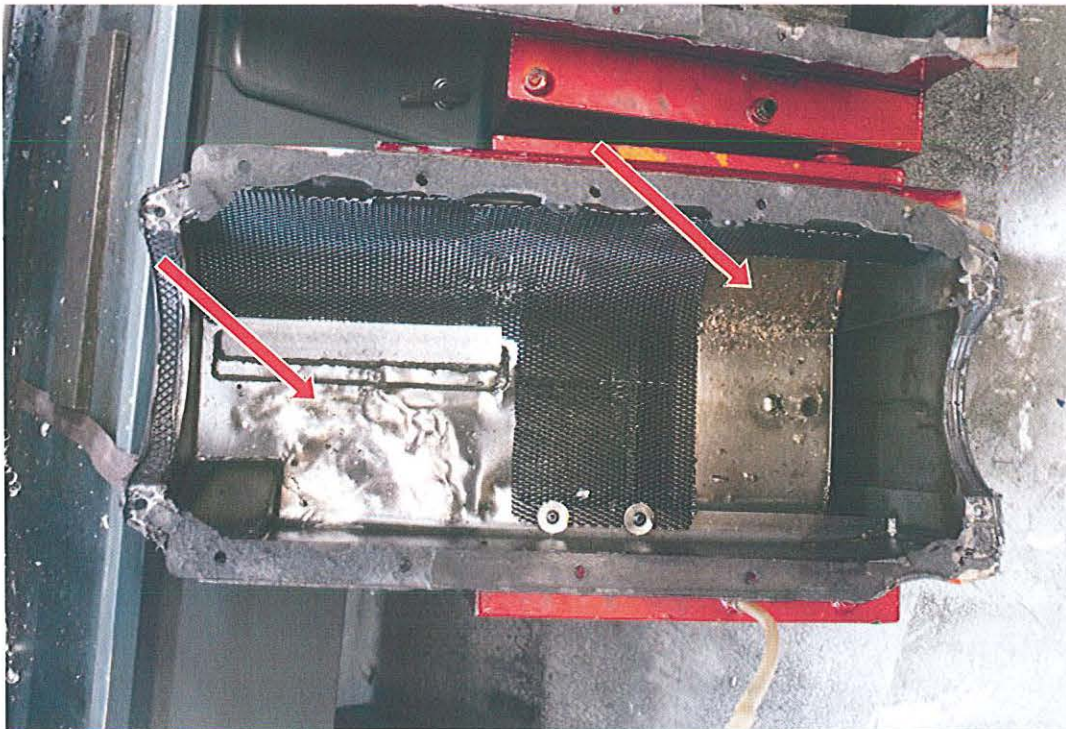
Figure A12 #377R: Deformation of oil pan and metal shavings in oil pan as shown by arrows

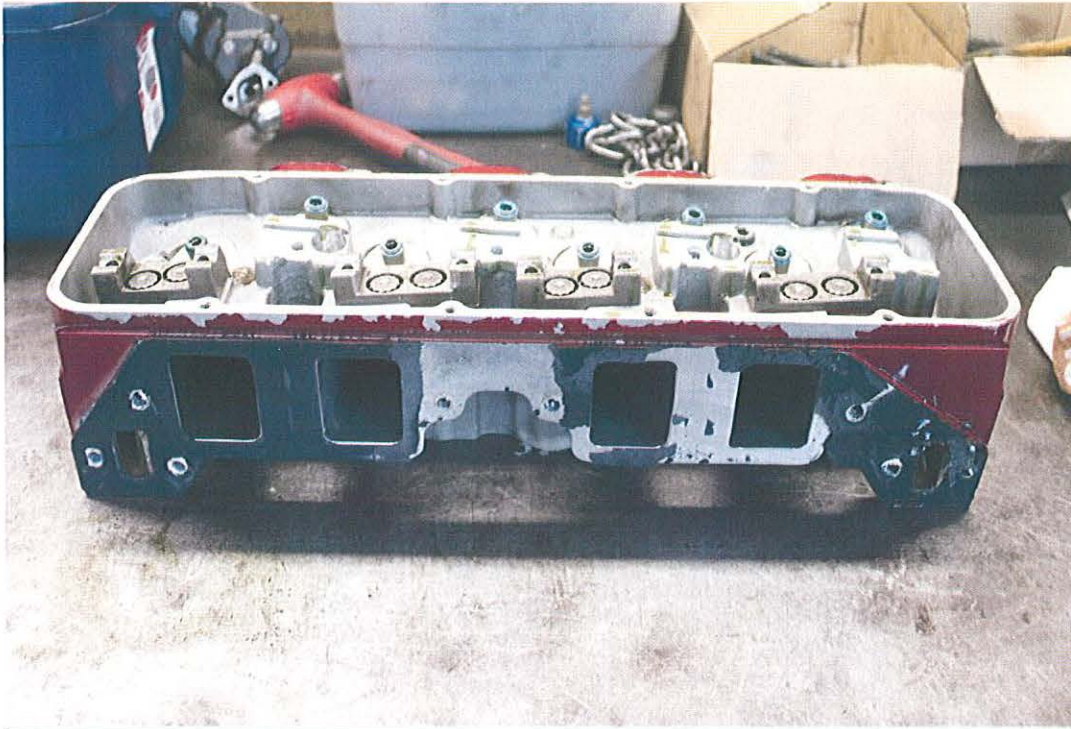
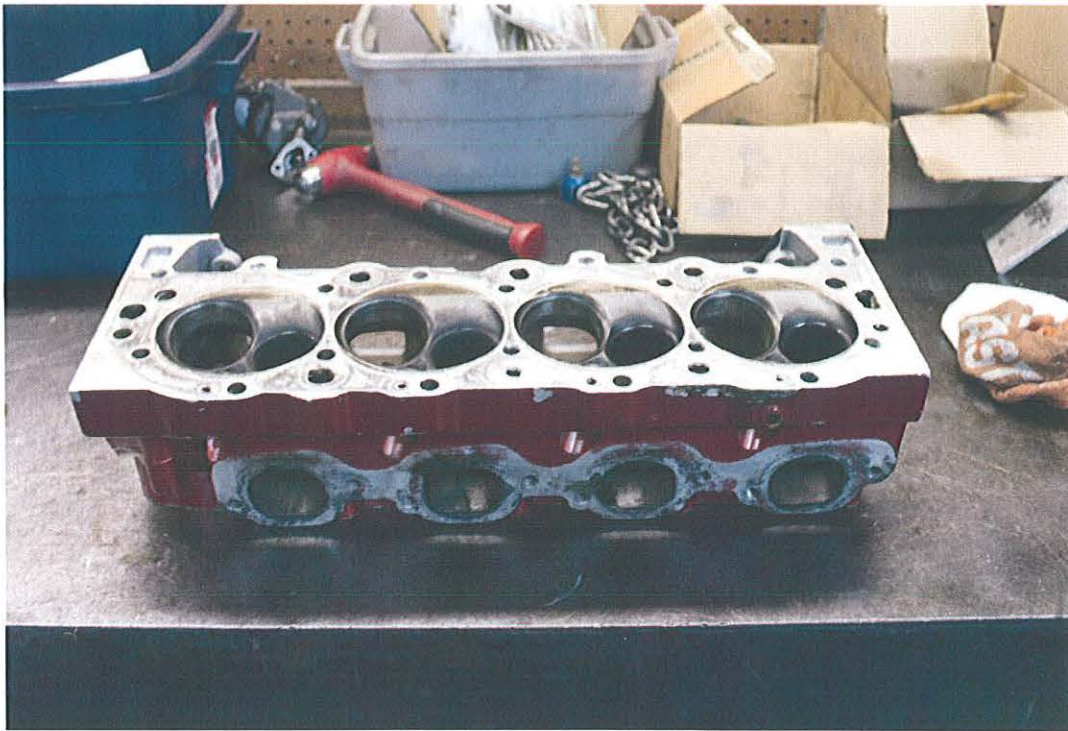
The cylinder heads were examined and there was no observable damage to either set as shown in example in Figures A13-A14. The intake and exhaust valves were examined and it was observed that some of the intake valves had carbonized build up adhered to the surfaces as shown in example in Figure A15. The valve covers were examined, in particular, the locations of the crankcase breather vents. It was observed that a baffle was welded to the inside of the valve covers, which impeded the crankcase breather vents from being fully open as shown in example in Figures A-16-A17. The valve covers were not labeled by MER, so it

Figure A13 #377R: Cylinder head for cylinders 1,3,5, and 7 valve train side

Figure A14 #377R: Cylinder head for cylinders 1,3,5, and 7 combustion chamber side

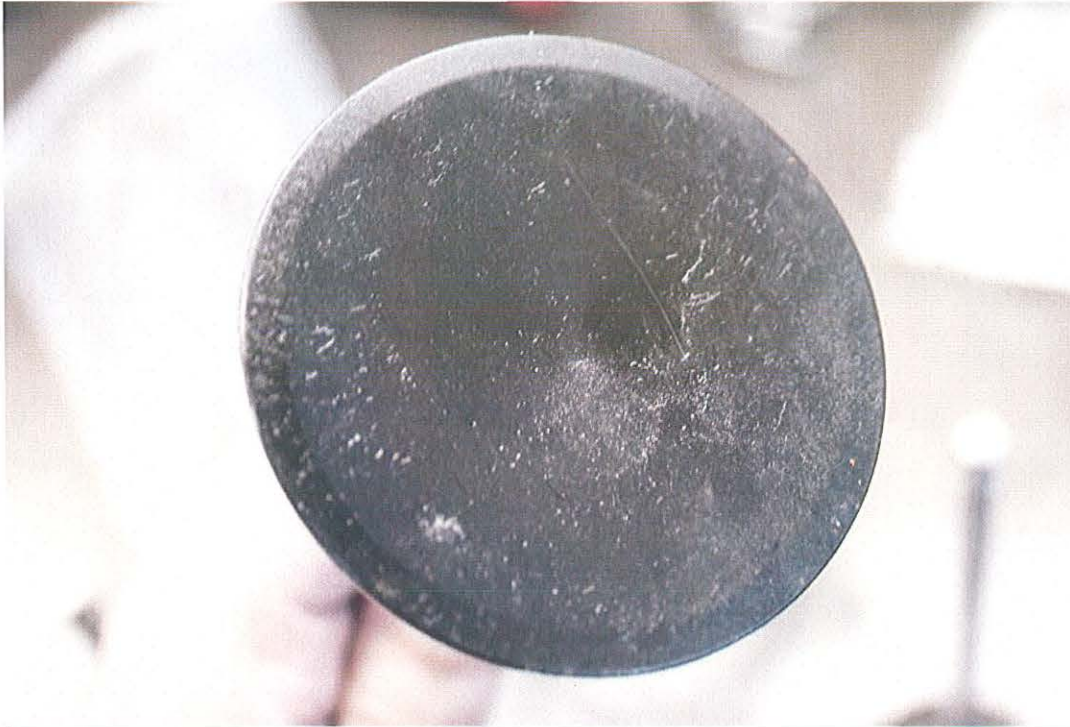
Figure A15 #377R: Carbonized buildup adhered to intake valve combustion side

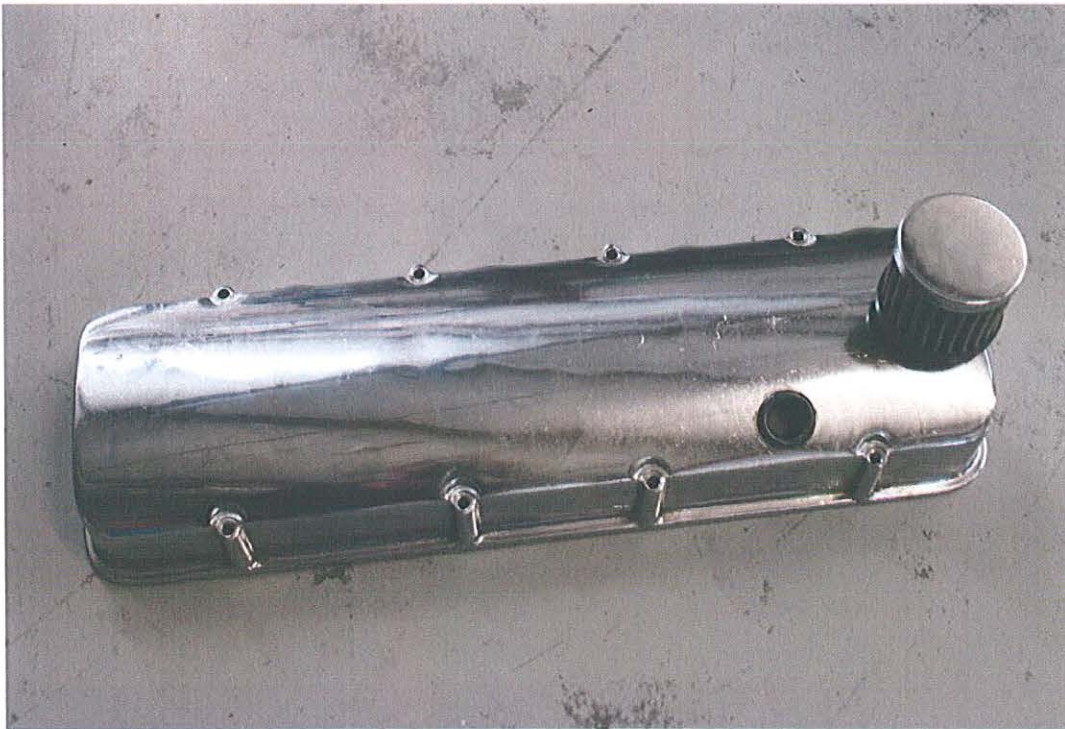
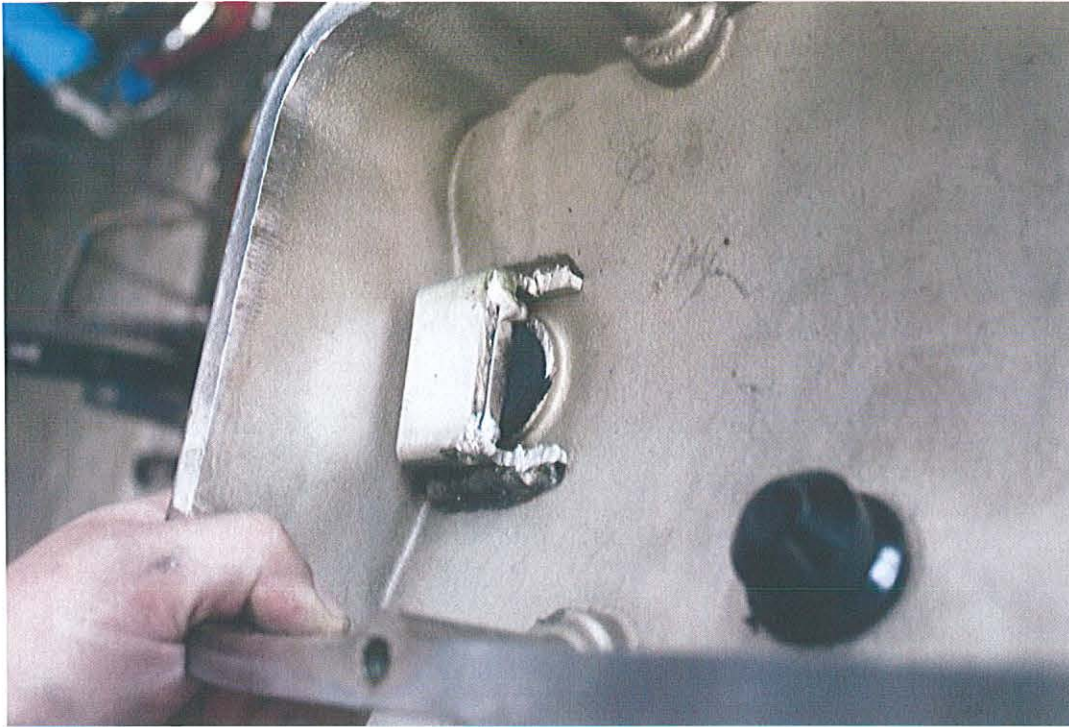
Figure A16 Typical valve cover top side with crankcase breather vent

Figure A17 Typical valve cover engine side showing baffle impedance with vent

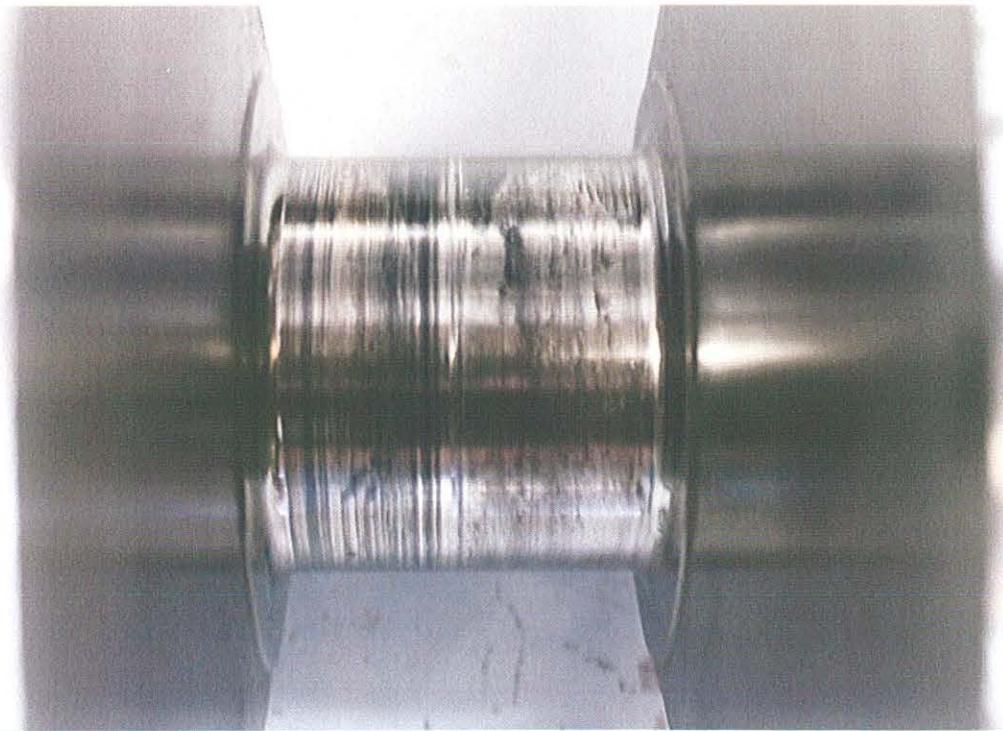
was not known by this investigation which valve covers were originally installed on either engine, however, the valve covers were of typical arrangement to each other. The crankshaft was examined and exhibited scratch marks around the circumference of several crankpin journals that indicated movement of the associated bearing as shown in example Figure A18.

Figure A18 #377R: Crankpin journal scratches

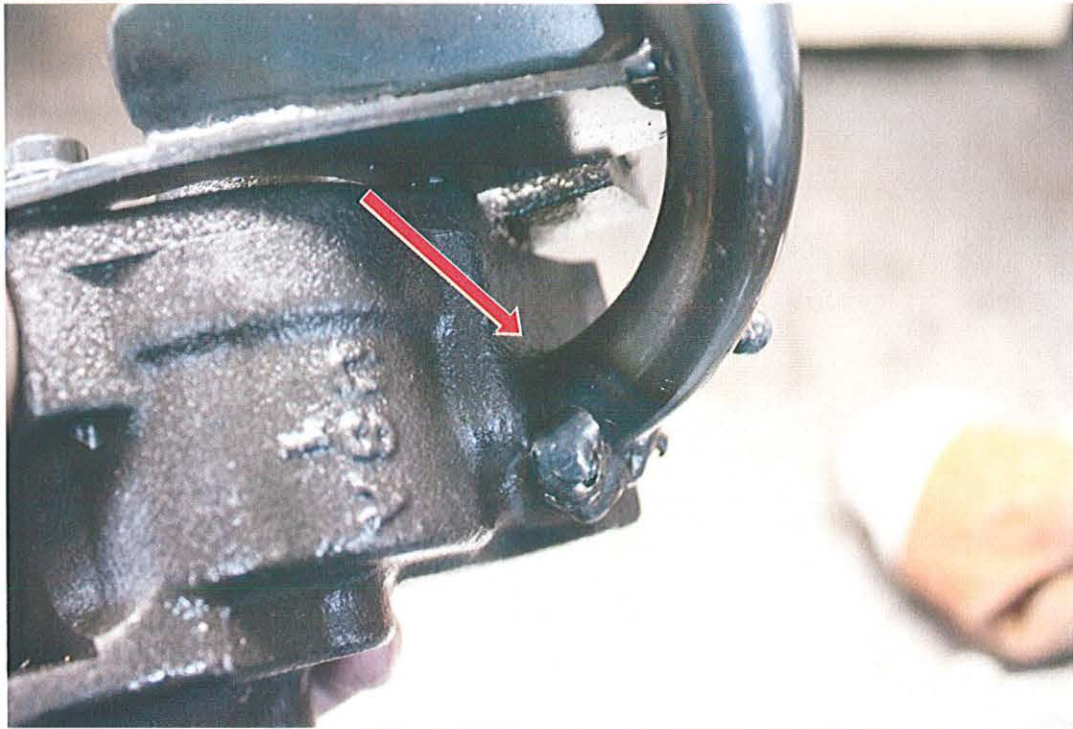
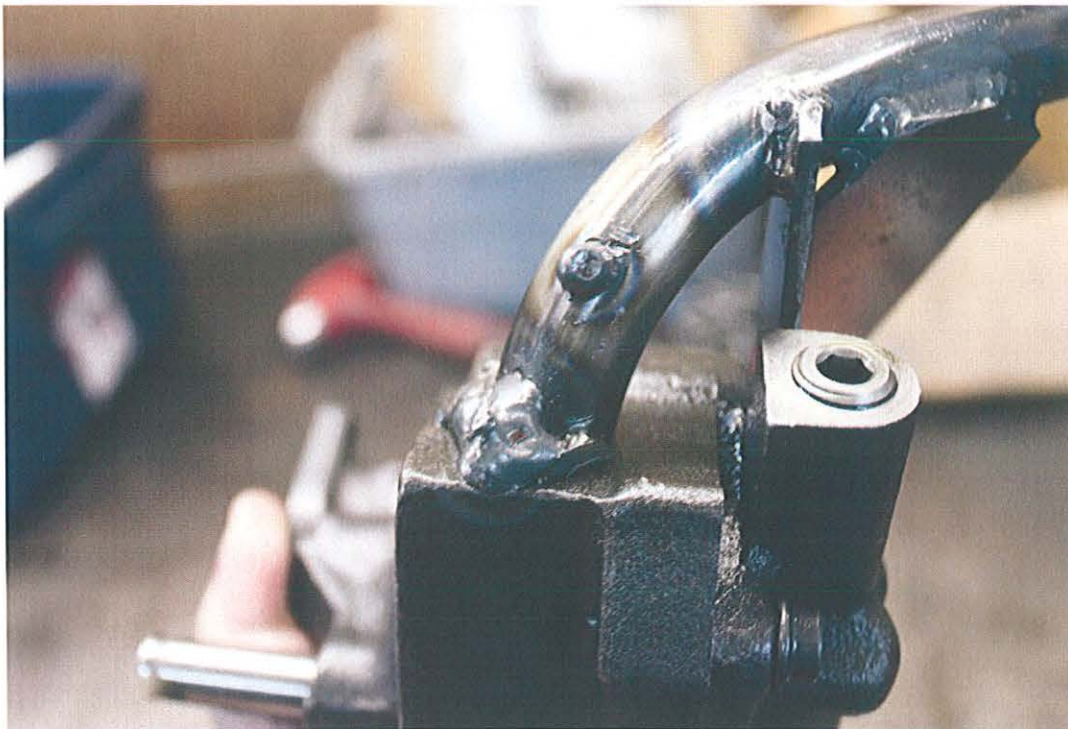
Lastly the oil pump and oil pickup tube were examined. It was observed that the pickup tube was not seam welded around the entire interface with the oil pump housing as is shown in Figures A19-A20. A sample of oil as collected by Mr. Rinda was examined and retained by this investigation. It was visually observed that the oil sample was of normal viscosity; however, the color was dark as is shown in Figure A21.

Figure A19 #377R: Oil pump and oil pump pickup tube partially welded interface

Figure A20 #377R: Oil pump and oil pump pickup tube partially welded interface

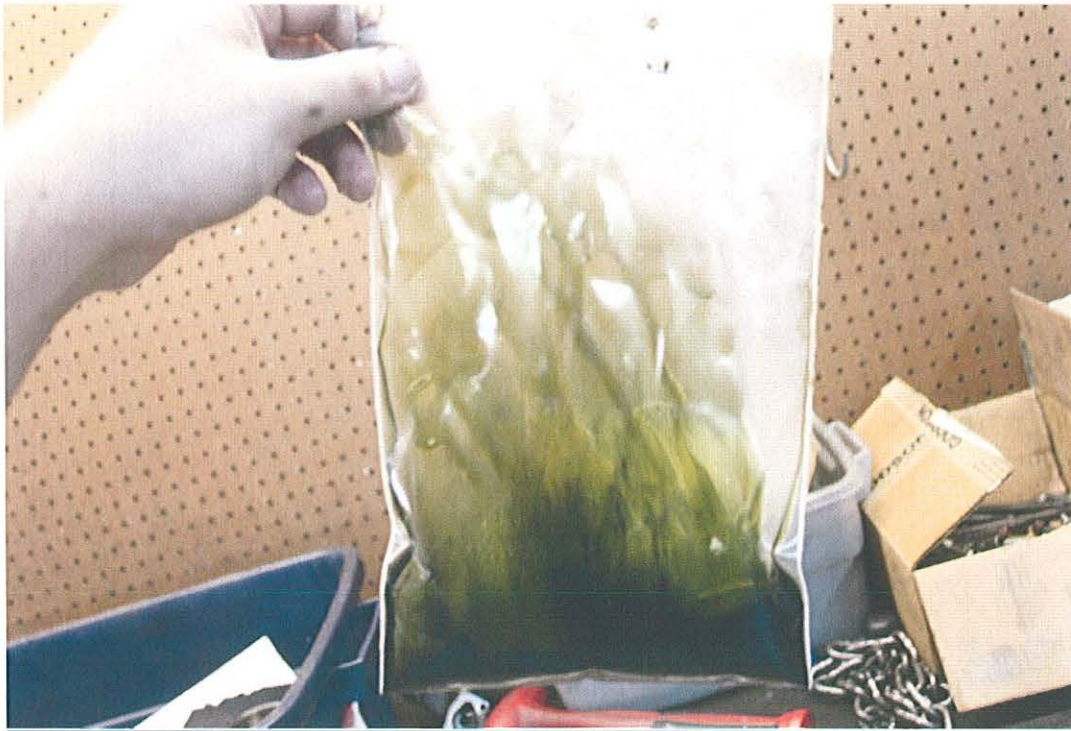
Figure A21 #377: Oil sample collected by MER

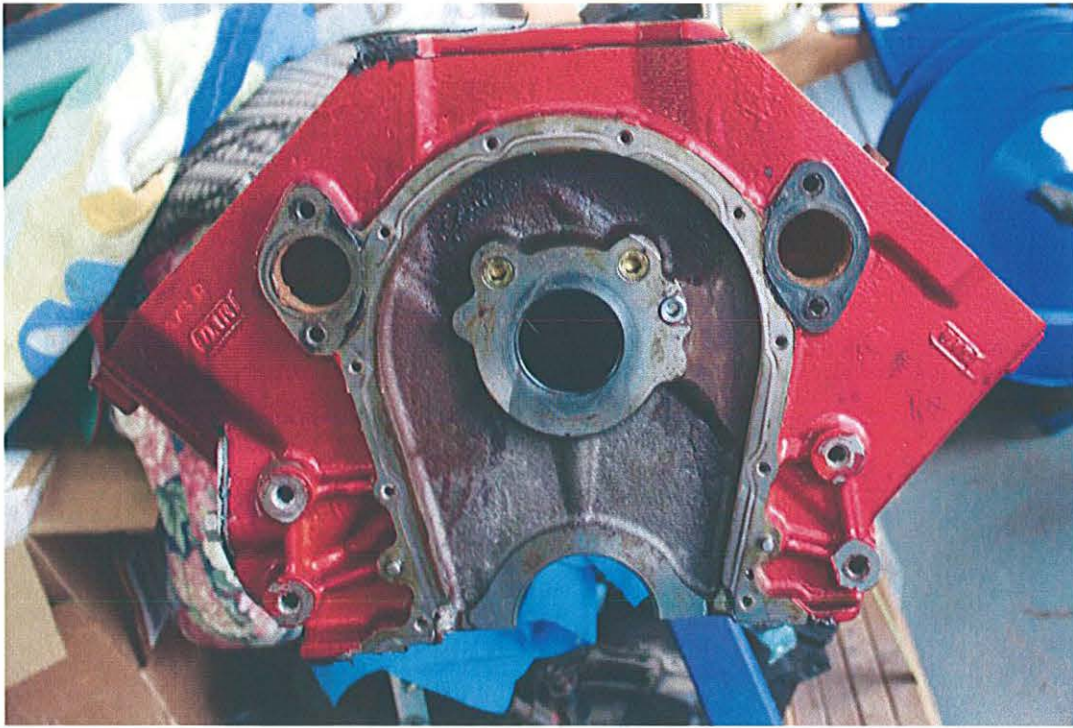
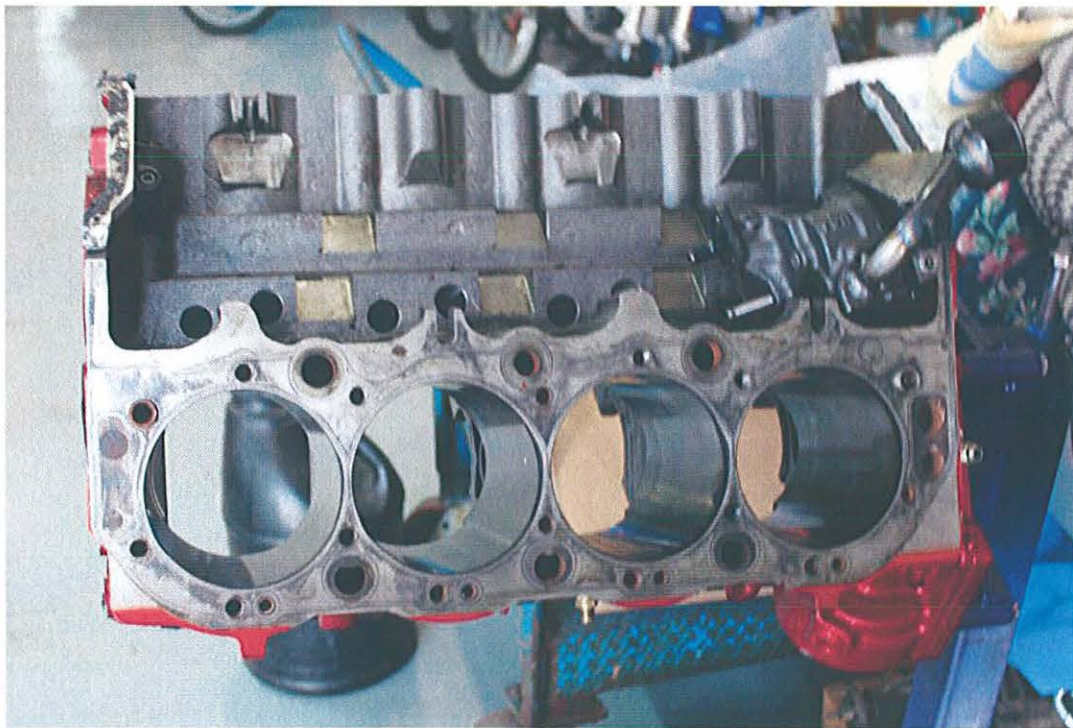
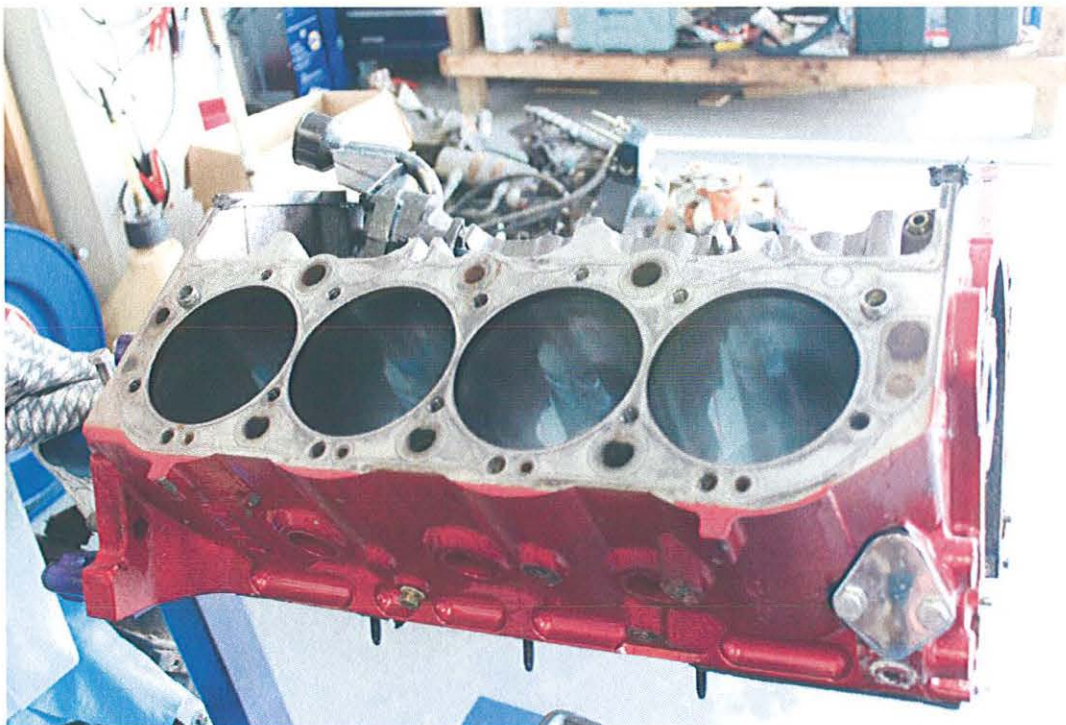
The overall condition of the engine block is shown in Figures B1-B3. The mechanical conditions of the engine components were examined. These included an examination of the engine block, cylinder walls, cylinder heads, intake and exhaust valves, piston heads, piston connecting rods, piston pins, piston rings, crankshaft, the associated bearings and bushings, valve covers, and oil pan. The cross-hatch patterns from honing of the cylinder walls, as shown in example in Figures B4-B5, were not consistent with a recent honing as it would be expected that they would have been more pronounced. Some of the connecting rod bearings exhibited signs of metal to metal contact and a degradation of the lubricating oil film between the bearings and the crankshaft as shown in example in Figures B6-B7. The main bearings exhibited cosmetic grooves on the surfaces; however, there was no indication of metal to metal contact. The piston pin bushings installed in the connecting rods exhibited minimal discoloration that was indicative of limited exposure to excess heat as shown in example in Figure B8. The pistons were examined and it was observed that heavy deposits were present on the crowns as shown in example in Figures B9-B10. The oil pan was examined and a thick oil residue was found adhered to the sides of the pan and along the bottom as shown in Figure B11.

Figure B1 #378R: Front of block (image cropped)

Figure B2 #378R: Cylinders 1,3,5, and 7 (image cropped)

Figure B3 #378R: Cylinders 2,4,6, and 8 (image cropped)

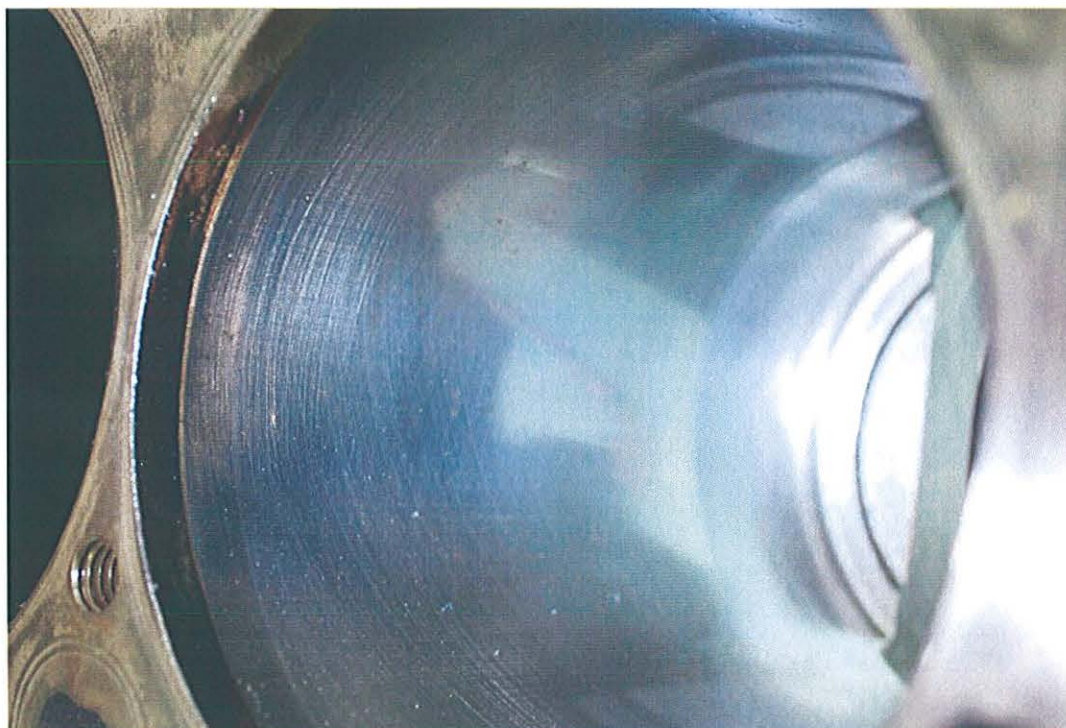
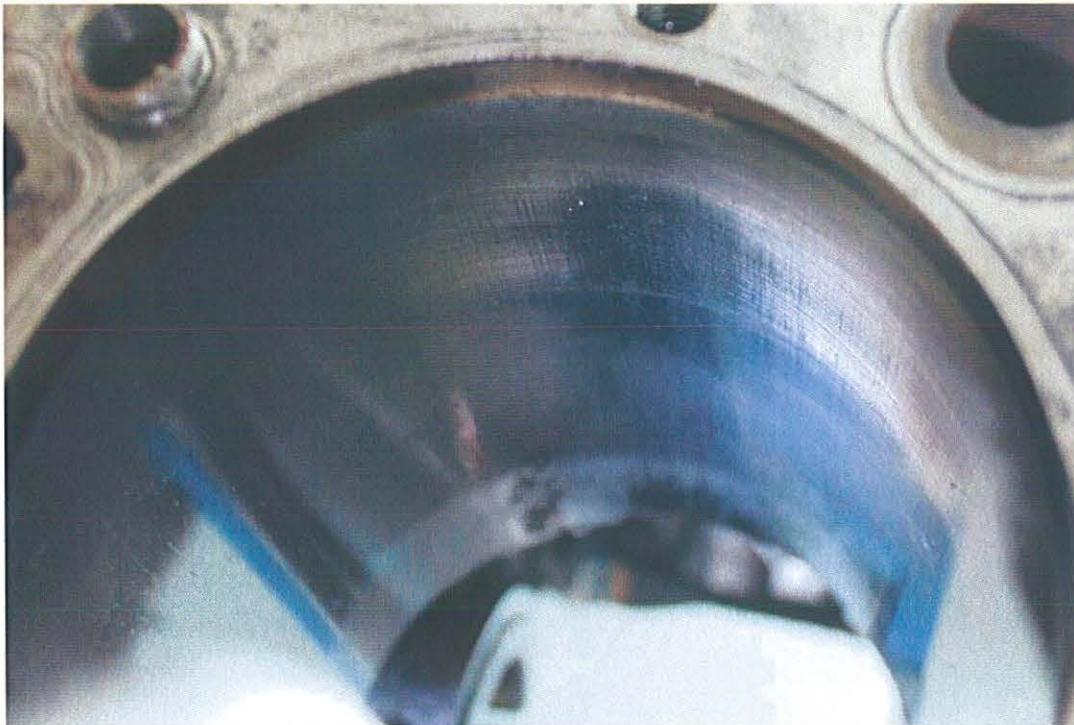
The cross-hatch patterns observed on the cylinder walls were not consistent with having been formed during the honing process just prior to being operated on the dynamometer at Crockett. The cross-hatch patterns would have been more pronounced and of a more reflective appearance in order to be consistent with a second recent honing process. It was therefore determined that the cylinder walls were not honed when the engine was sent back to Crockett as reference by the March 12, 2011 invoice.

Figure B4 #378R: Cross-hatch patterns in cylinder #2 (image cropped)

Figure B5 #378R: Cross-hatch patterns in cylinder #8 (image cropped)

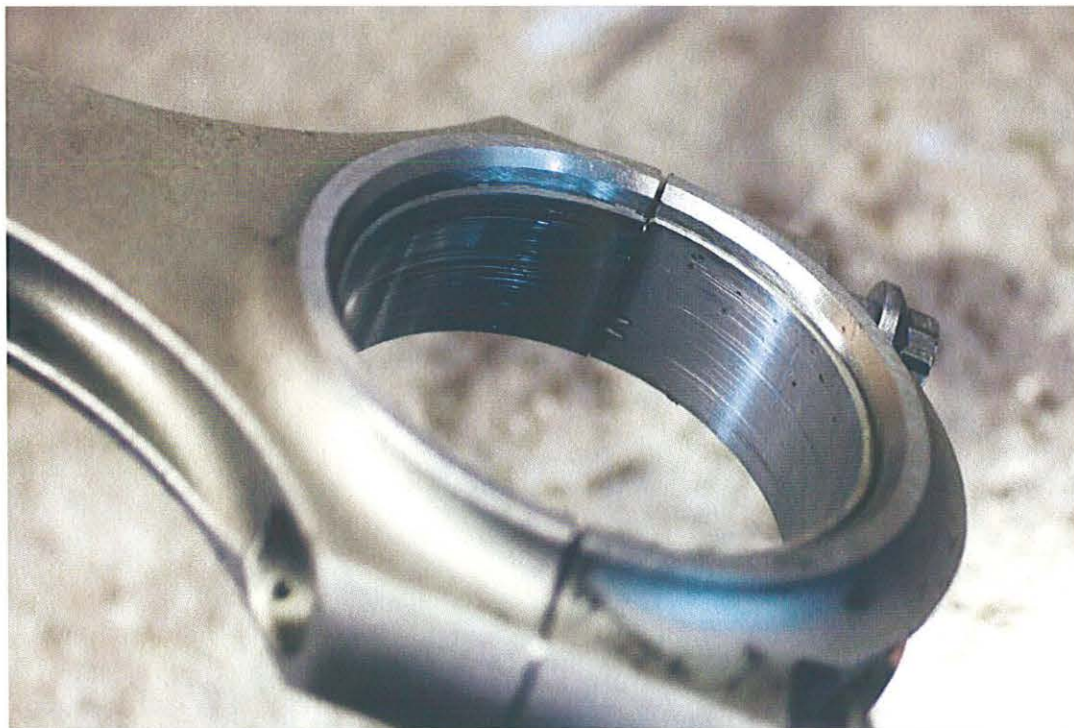
Figure B6 #378R: Indication of metal to metal contact on cylinder #6 connecting rod bearing (image cropped)
